DOT/FAA/CT-83/10

## Evaluation of an Improved Flame Resistant Aircraft Window System

George B. Geyer  
Charles H. Urban

Final Report  
May 1984

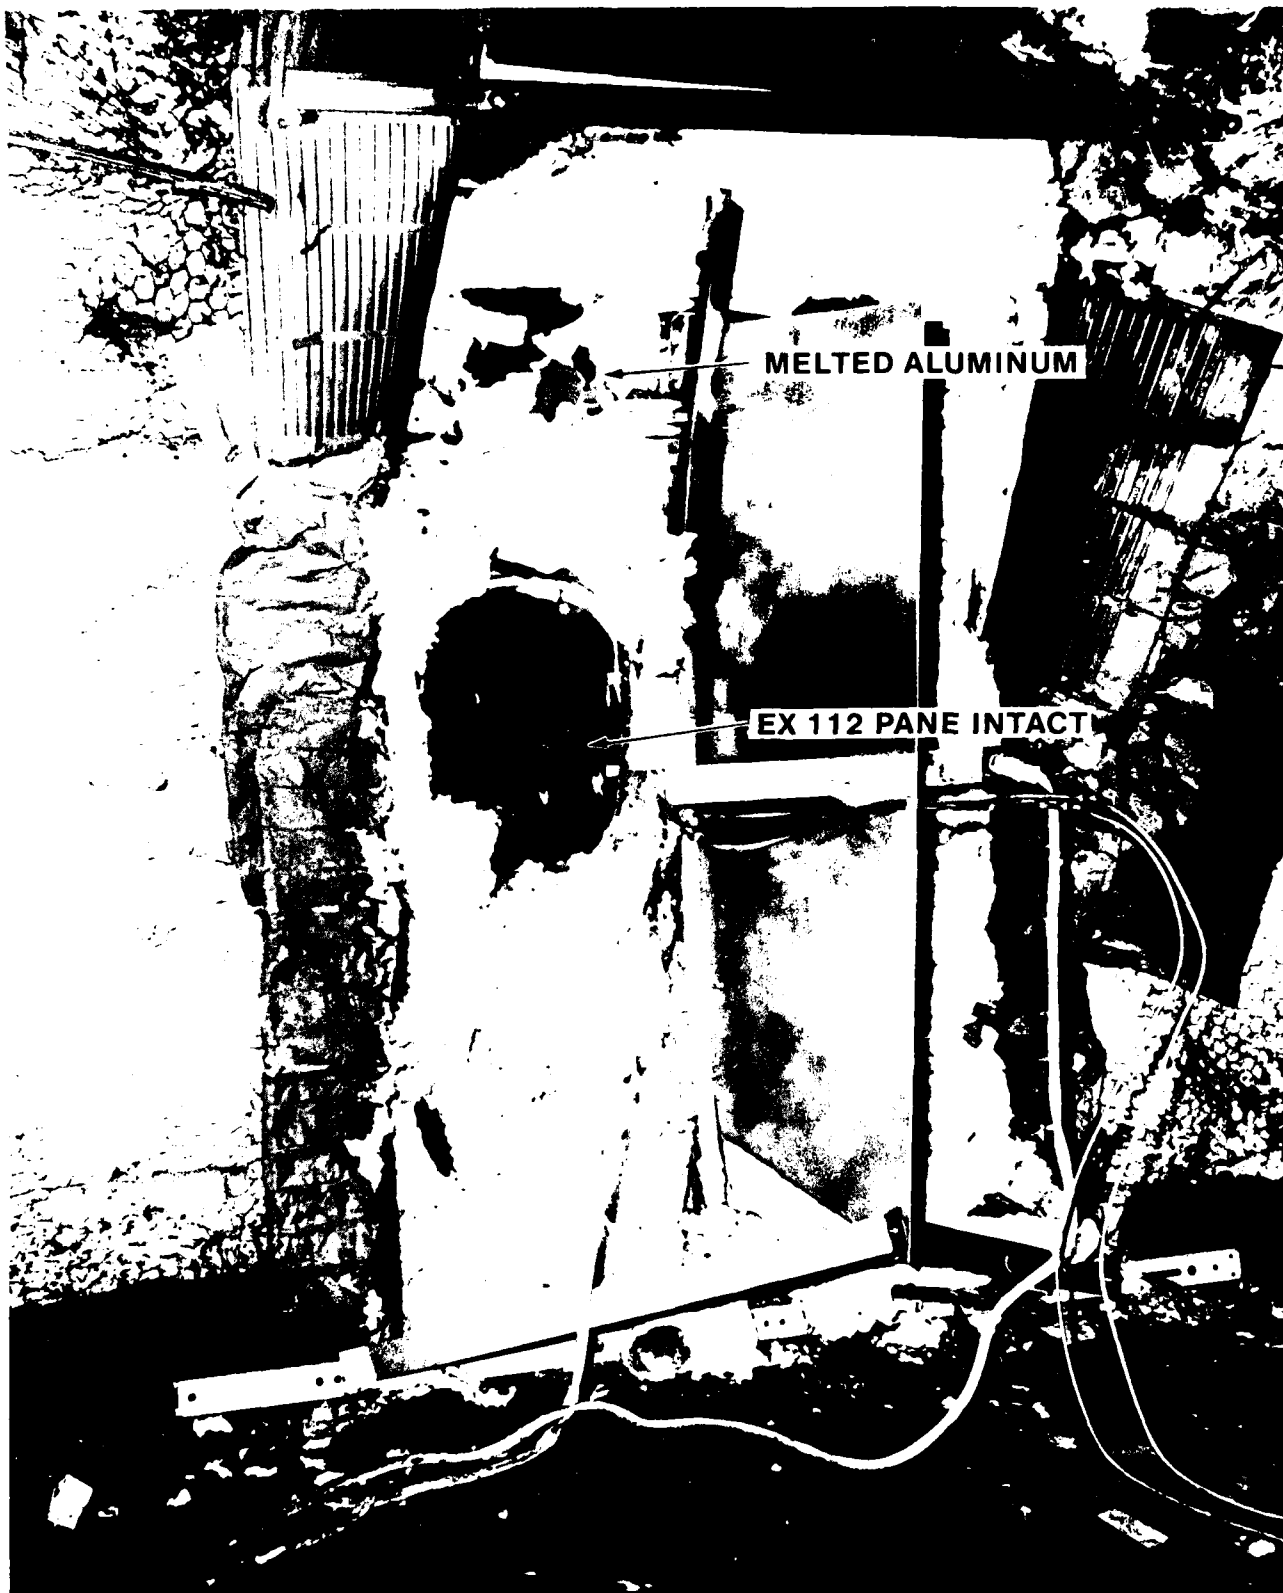
FIGURE 8. FIRE DAMAGE TO THE THERMALLY IMPROVED DC-10 WINDOW SYSTEM SHOWING THE FAIL-SAFE (EX 112) PANE IN PLACE (TEST 1)

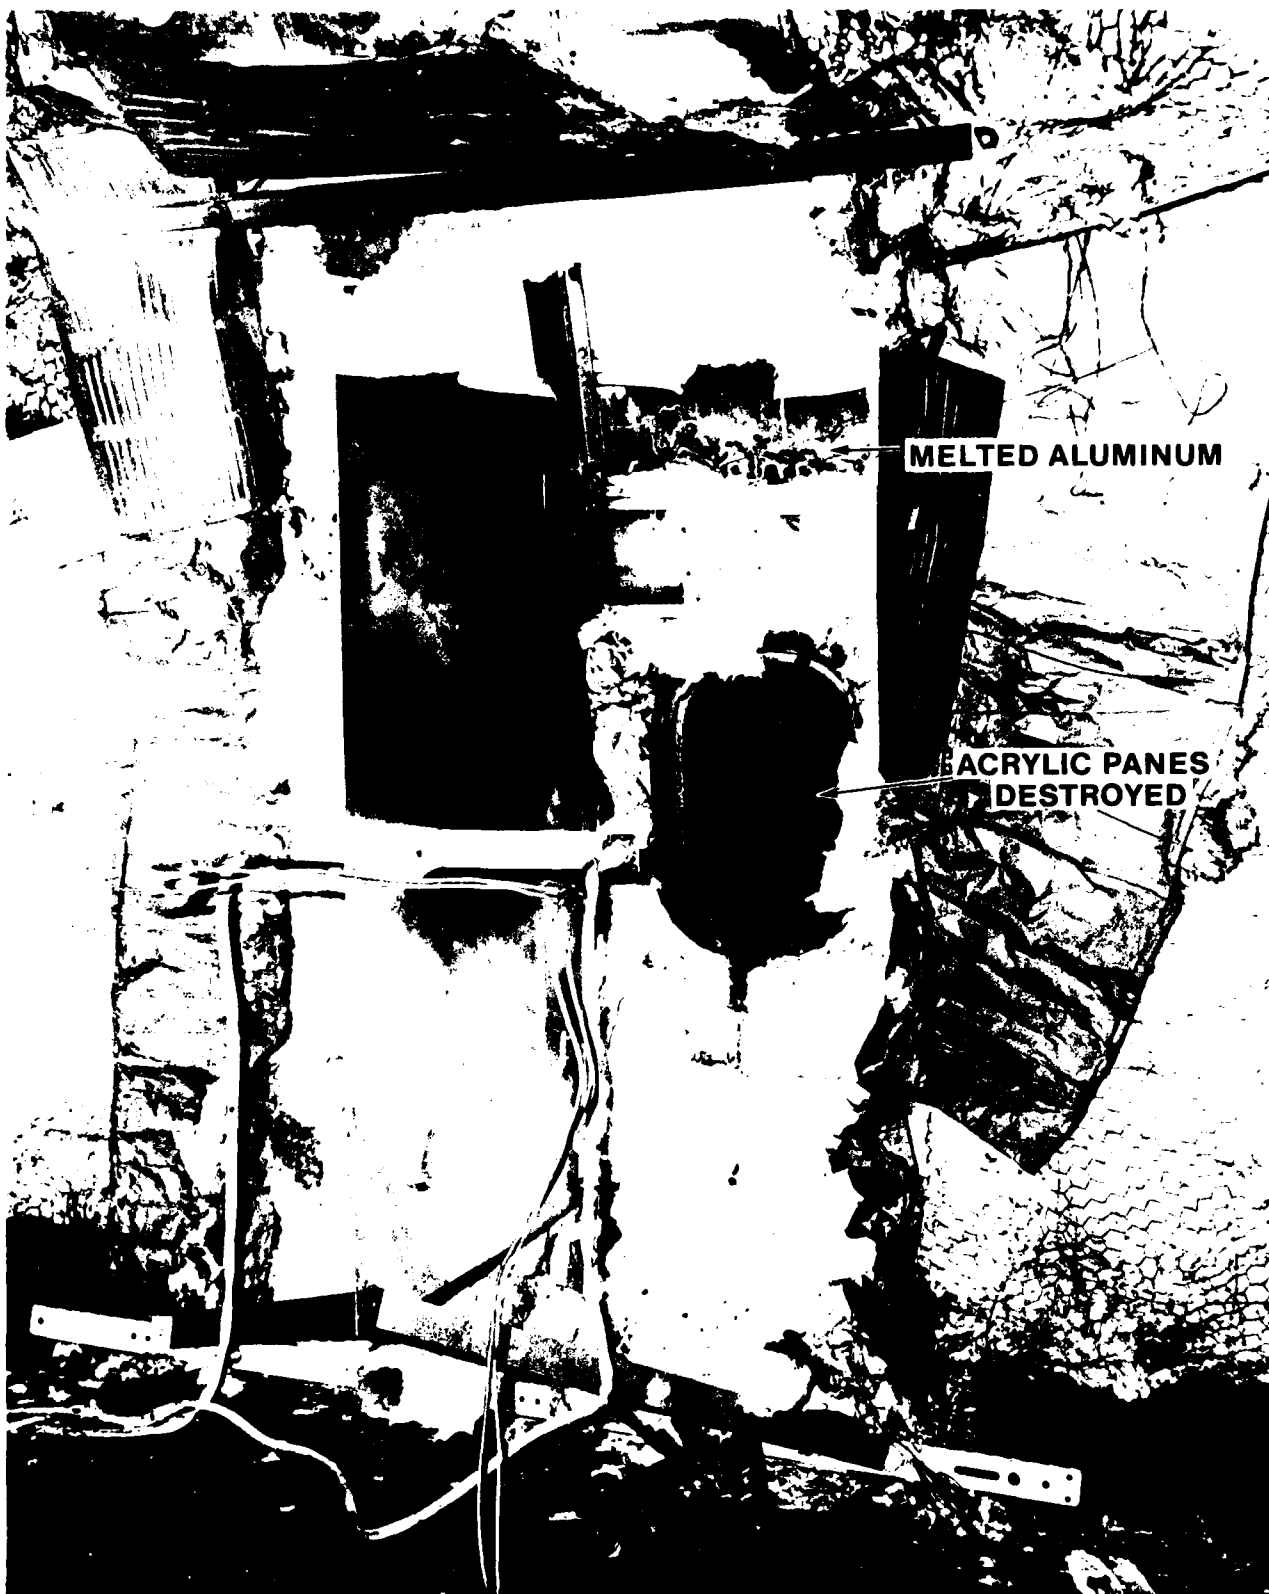
FIGURE 9. FIRE DAMAGE TO THE STANDARD DC-10 WINDOW SYSTEM SHOWING THE COMPLETE DESTRUCTION OF THE ACRYLIC WINDOW PANES (TEST 1)

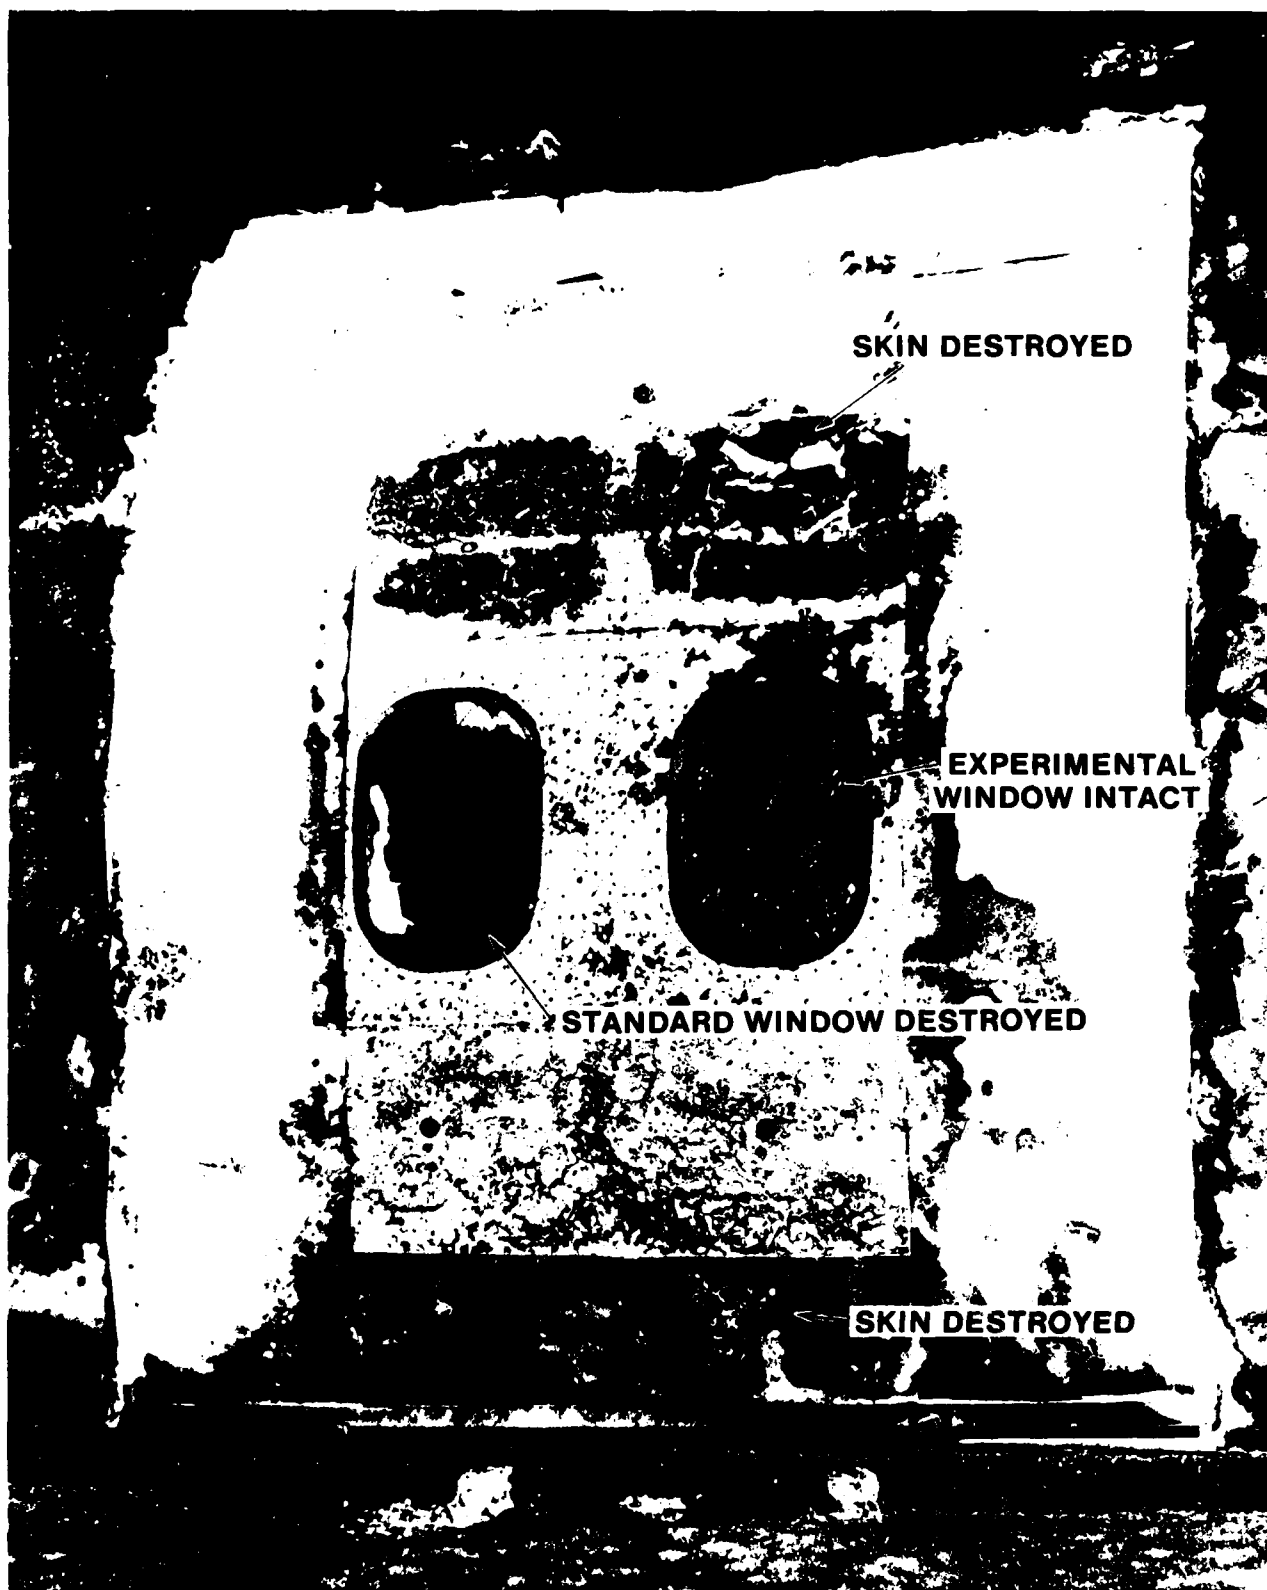
RESULTS: The temperature rise of the DC-10 fuselage segment during fire exposure in test 1 is indicated by the profiles presented in figure 7 for the aluminum skin and belt areas. These data show that the aluminum skin above the windows started to melt in 64 seconds (1.07 minutes) which was confirmed by an analysis of the photographic coverage. However, the skin below the windows and belt area did not reach the incipient melting temperature for aluminum of 900° F until 198 seconds (3.3 minutes) after fuel ignition. The fire damage to the skin above the improved (EX 112) window system is shown in figure 8 and above the acrylic window in figure 9. A more detailed interior view of the failure mode of the fuselage skin in these areas is presented in figure 10. An overall exterior view of the fire damage sustained by the DC-10 fuselage segment is presented in figure 11.

FIGURE 11. EXTERNAL FIRE DAMAGE TO THE DC-10 WINDOW SYSTEMS (TEST 1)

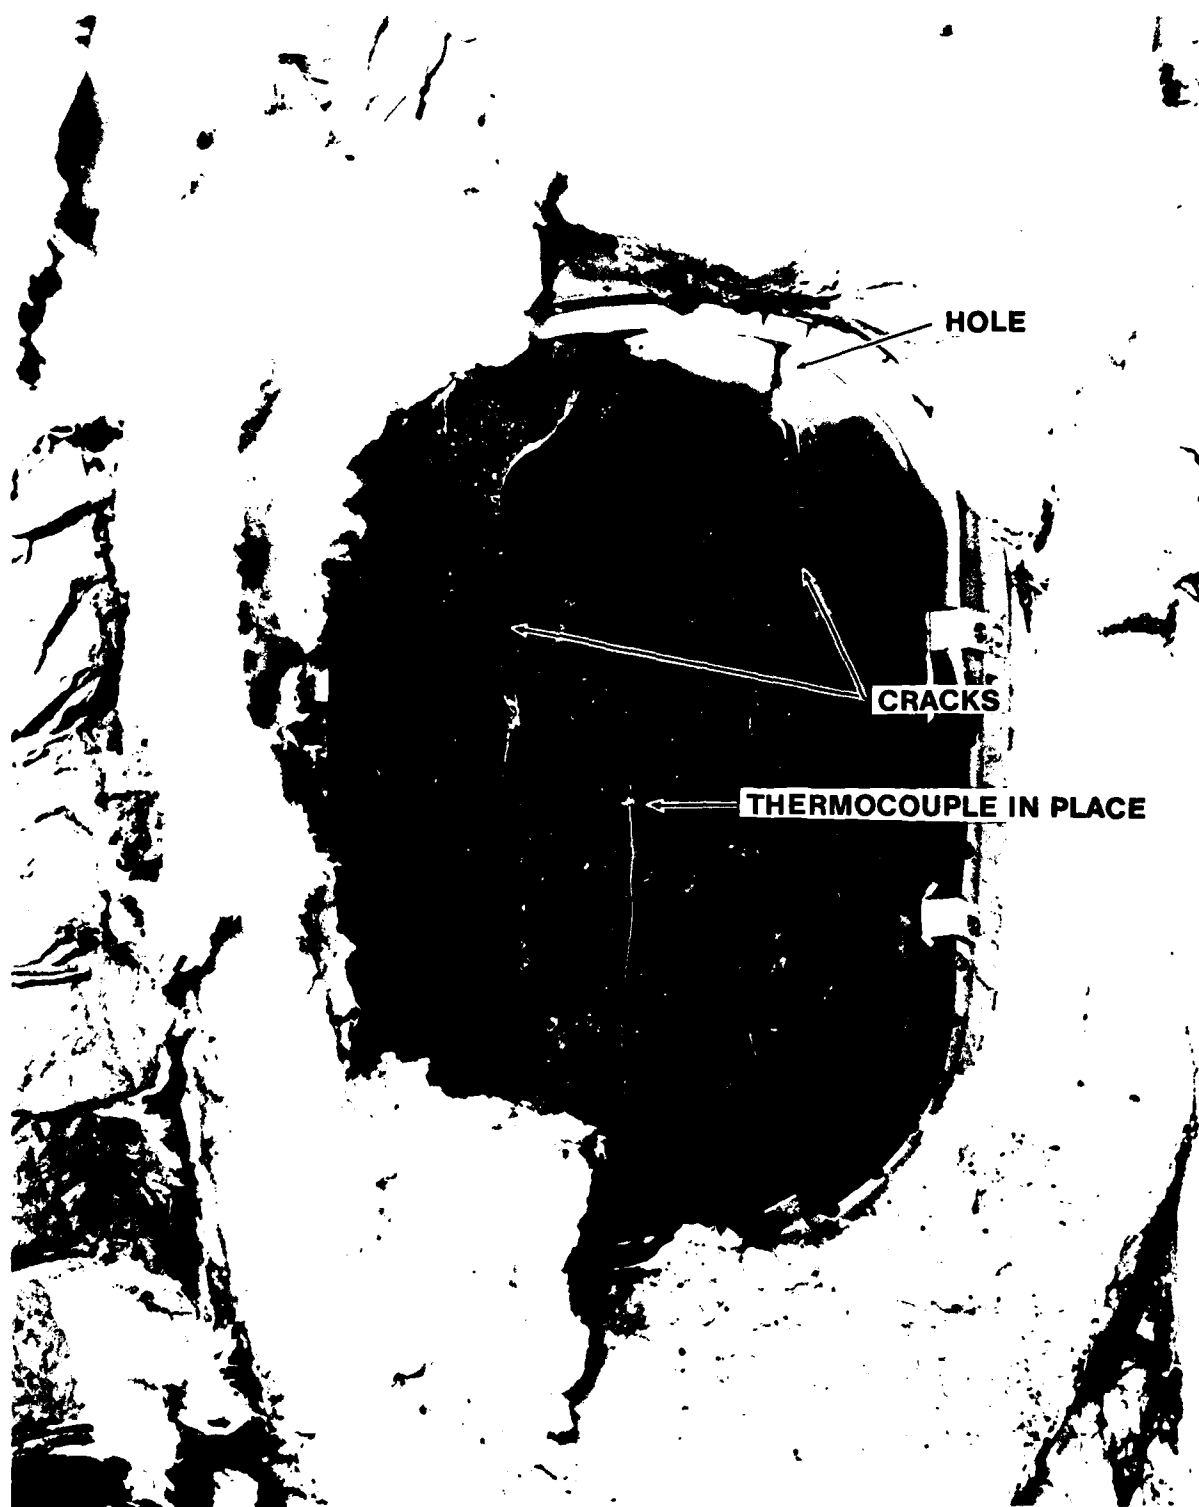
FIGURE 14. CLOSE-UP VIEW OF THE FIRE DAMAGE TO THE FAIL-SAFE (EX 112) WINDOW PANE (TEST 1)

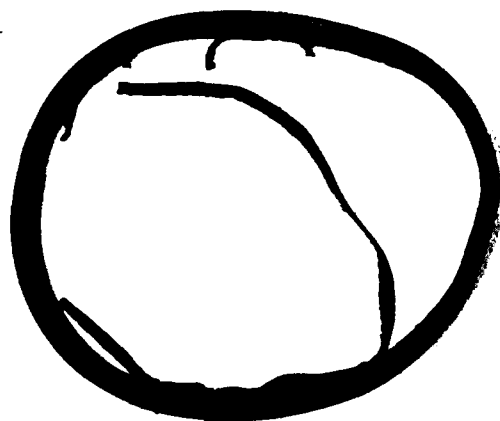
A detailed examination of the condition of the silicone gasket after it was removed from the window frame revealed it had retained a large part of its structural integrity and flexibility (figure 15). The thermal resistivity demonstrated by the gasket under severe fire exposure is noteworthy and its survival is attributable in part, to the thermal resistance of the EX 112 fail-safe pane, the relatively high specific heat of aluminum and the mass of metal comprising the belt system.

SMALL CRACKS

FAIL-SAFE EX 112  
PANE WITH GASKET

FAIL-SAFE ACRYLIC PANE AND GASKET

FIGURE 15. FIRE DAMAGE SUSTAINED BY THE IMPROVED EX 112 FAIL-SAFE  
PANE AND THE STRETCHED ACRYLIC PANE (TEST 1)

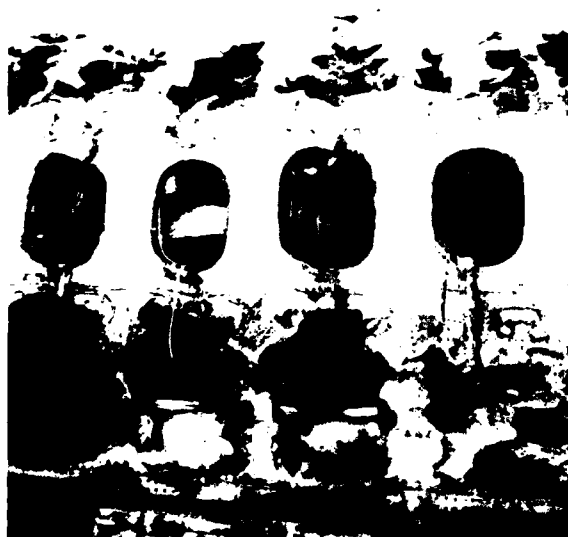
The higher heat resistance of the belt system over the fuselage skin is evident in the photographs presented in figure 17 of the Continental Airlines DC 10-10 accident on March 1, 1978 at the Los Angeles International Airport. This failure mode, in general, was consistent with that observed in the first and subsequent tests conducted in the C-133 fire test bed.

(a) General View of the Fuselage Damage

(b) Detailed View of the Belt System Area

FIGURE 17. FAILURE MODES OF THE CONTINENTAL AIRLINES DC-10 AIRCRAFT  
FUSELAGE SKIN AND WINDOW BELT SYSTEM

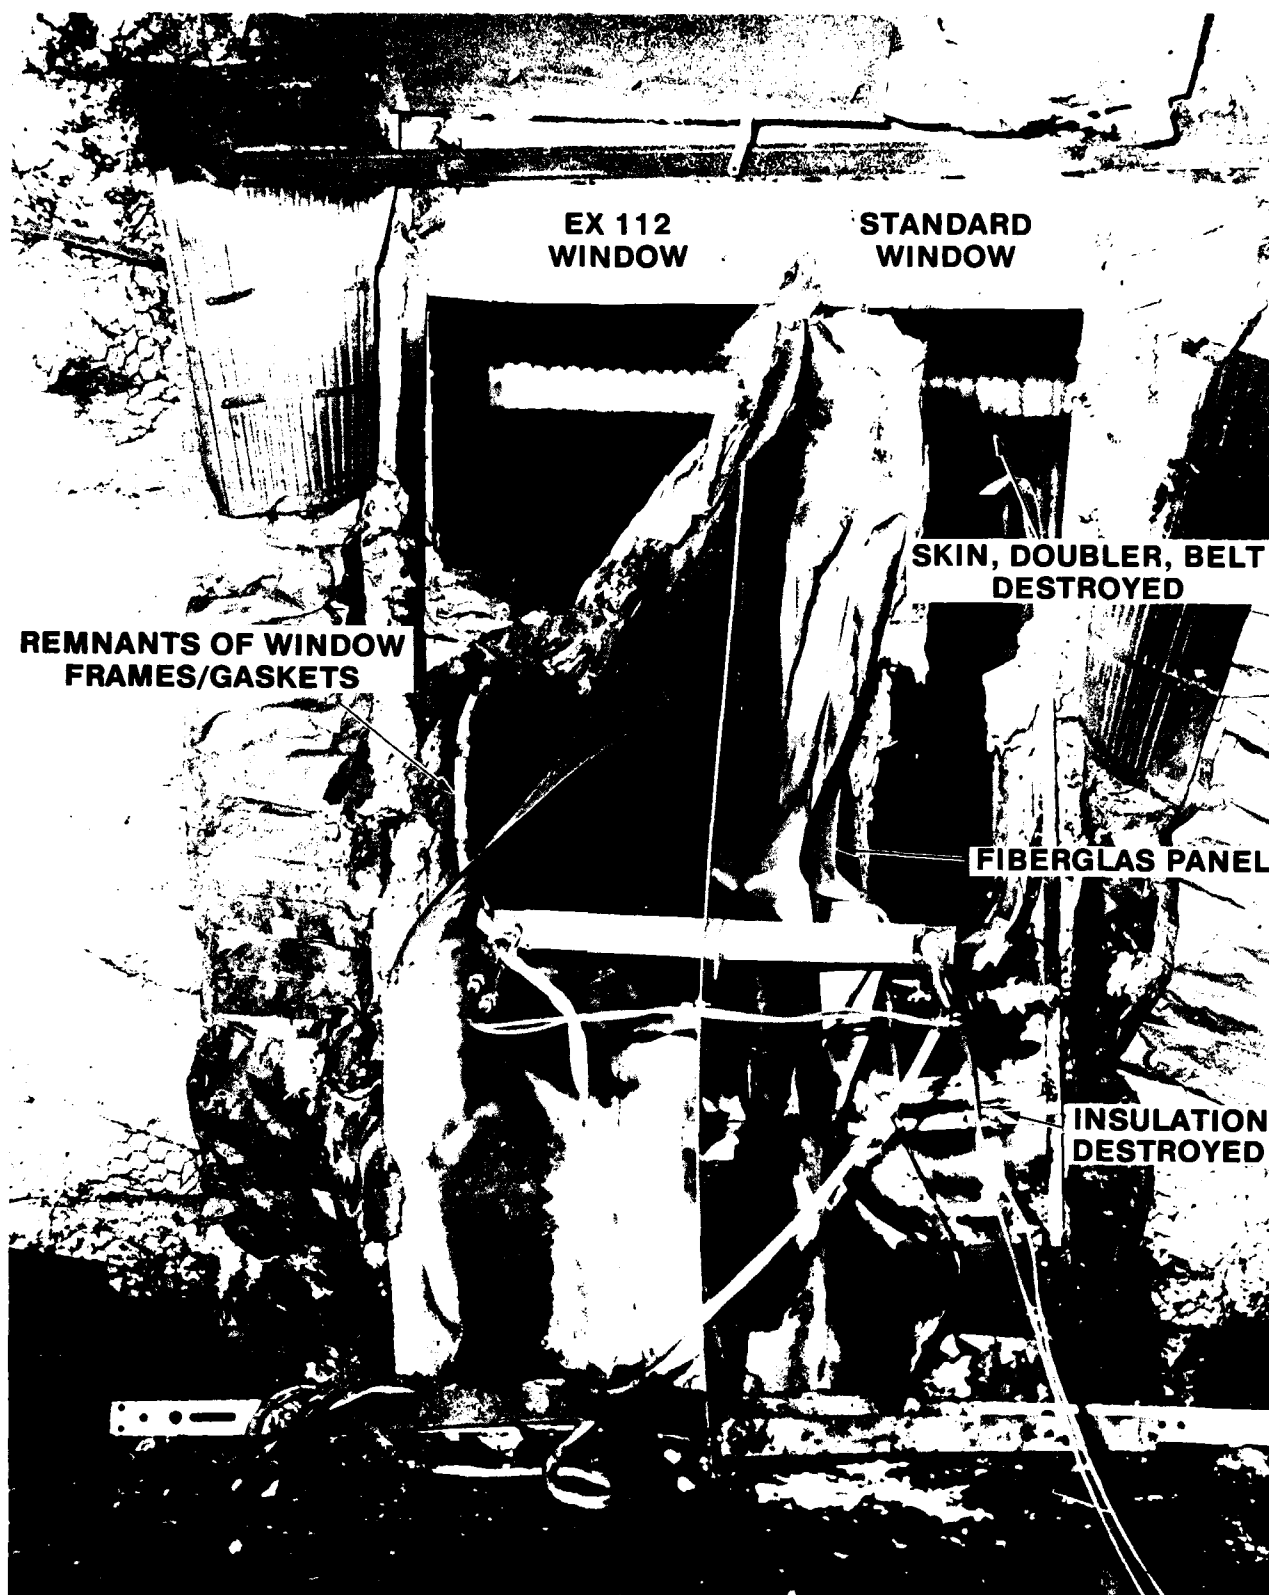
The visual fire damage to the aluminum fuselage structure around the thermally improved and standard window configuration is shown in figure 24. A more detailed interior view of the fire damage to the improved EX 112 window system is presented in figure 25. Figure 24 shows a portion (approximately 25 percent) of the silicone rubber gasket still mounted in position in the window opening around the thermally improved window system. From these photographs it is evident that the integrity of any window system comprising a pressure and fail-safe pane mounted in a rubber gasket is dependent heavily upon maintaining the structural and thermal integrity of the belt and window framing material.

FIGURE 24. FIRE DAMAGE TO THE STANDARD (ACRYLIC) AND IMPROVED (EXIT 112) WINDOWS (TEST 2)
